An Evaluation and Analysis of Past Landfill Closures in Puerto Rico as Guidance for Current and Future Closures

STREAMS Task Order 99

Innovative Waste Consulting Services, LLC
Gainesville, Florida

September 2011

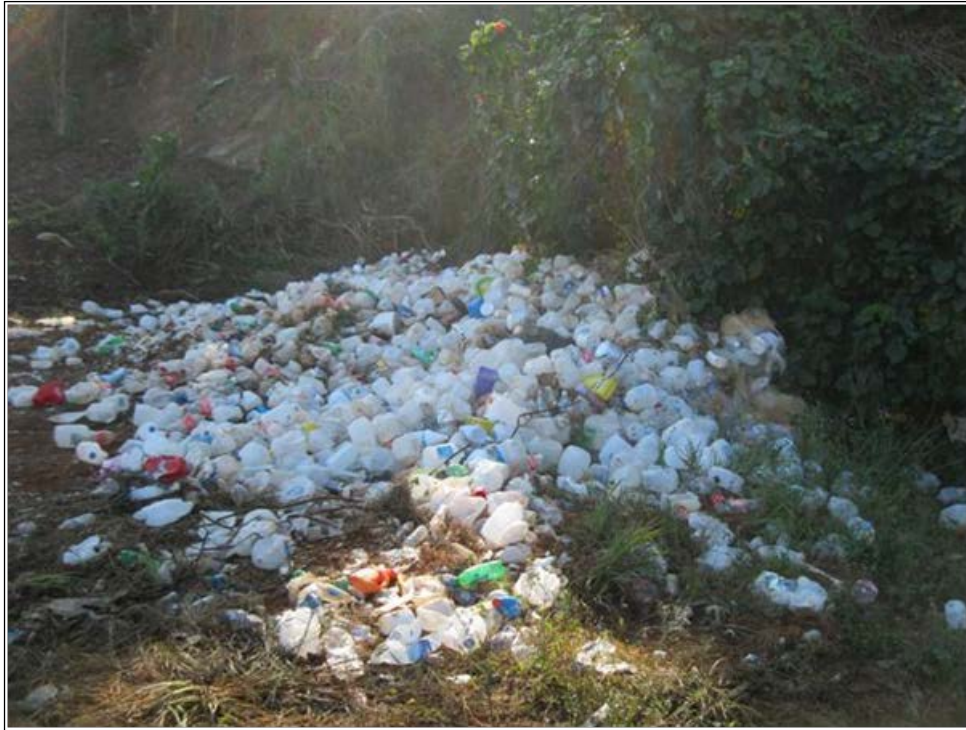
No leachate seeps were observed on the top surface of the landfill. Localized piles of newly-placed garbage (mostly bagged municipal solid waste and loosely-placed vegetative waste) were present at the northern edge of the site and a large pile of sorted plastics were found at the southern edge of the site (Figure 3-4). Information provided by an individual that was in one of the on-site buildings indicated that the Municipality of Rincón routinely picks up

Figure 0-4. Stockpile of Sorted Plastics at the Rincón (1) Municipal Landfill

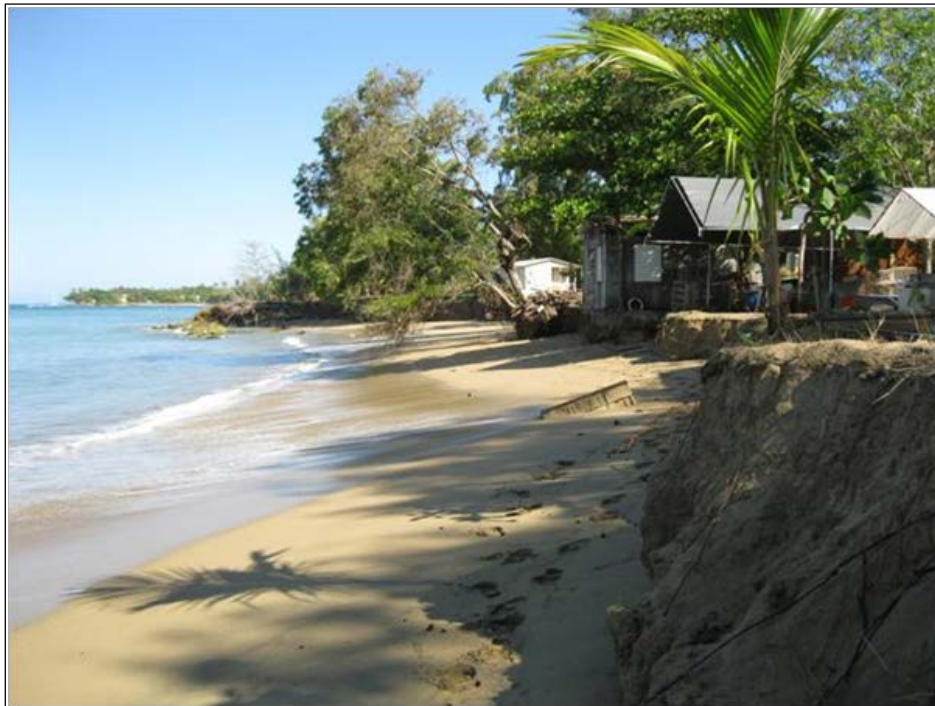
A large portion of the western edge of the site was in direct contact with the waves of the Caribbean Sea (Figure 3-7). Anecdotal information from the residents at the site suggested that the landfill historically extended further to the west but had been eroded over the years (Figure 3-8), though an estimate of how far to the west the landfill extended historically was not known. An analysis of erosion of the coastline Rincon conducted by the USGS suggested that the stretch of coastline where the landfill lies has been subject to substantial erosion with an average recession rate of 1.1 m/year (USGS 2007). Thus, it is possible that the landfill was larger and extended further west at one time. Because of the proximity of the landfill to the sea and the impact of the tides on the landfill, the western slopes of the landfill ranged from relatively flat to 1-4 ft thick vertical walls.

Figure 0-7. Eroded Western Edge of Rincón 2

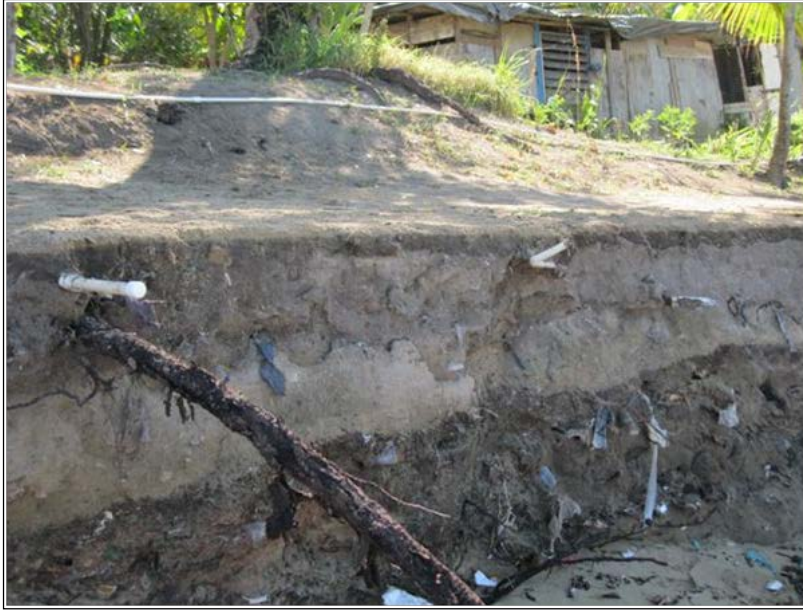
Figure 0-8. Stratification of the Western Edge of Rincón 2

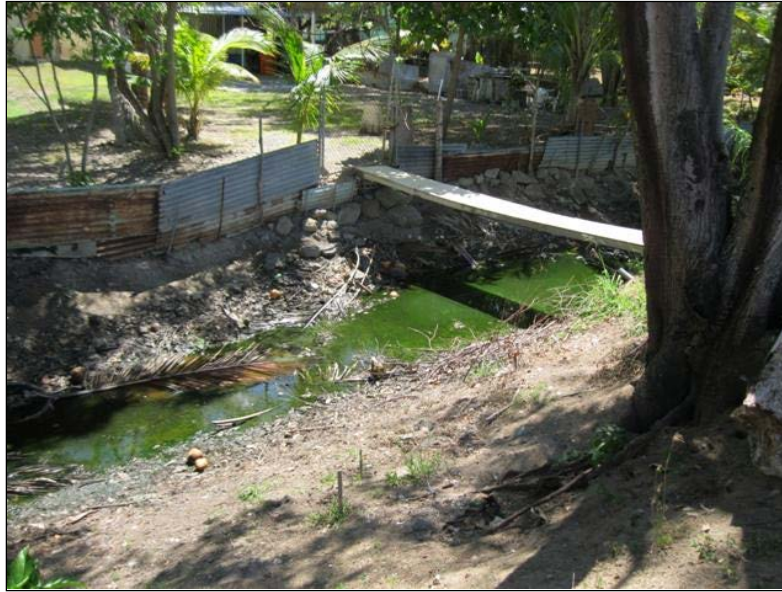
Leachate seeps were not witnessed directly; however, since much of the western edge of the waste is exposed to the tides, leachate (by definition) is constantly being generated and discharged into the sea. A small area of riprap was emplaced along a south-facing portion of beach. Anecdotal information gathered from residents during the site visit suggested that the riprap was placed to reduce the amount of waste washout towards the north. The riprap was mentioned in the previously-referenced US Fish and Wildlife Service e-mail and indicated that the riprap had caused further erosion in the unprotected sand beach. A ditch that ran along the eastern side of the landfill contained a liquid that appeared to be leachate, but this ditch appeared to be an area where the nearby residents discharged their wastewater, so a differentiation between potential leachate and municipal wastewater was not possible (see Figure 3-9). No leachate control systems were found at the site.

Figure 0-9. Ditch to the east of the Closed Rincón Landfill.

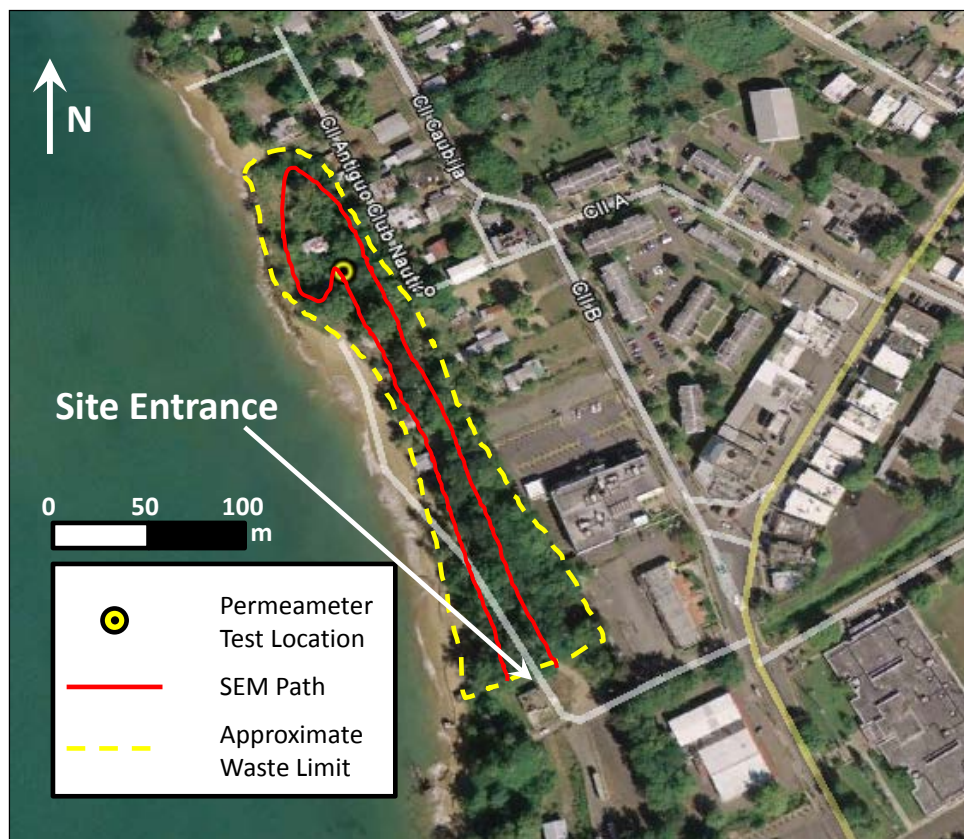
No methane surface emissions were detected above background levels during the monitoring event. No evidence of a clay cover was present, but the measured hydraulic conductivity of the site soils (1.3×10^{-4} cm/s) was an order of magnitude greater than the Puerto Rico Non-Hazardous Solid Waste Management criterion of 1×10^{-5} cm/sec. Appendix C contains additional details regarding the calculation of the hydraulic conductivity of the soil at Rincón 2.

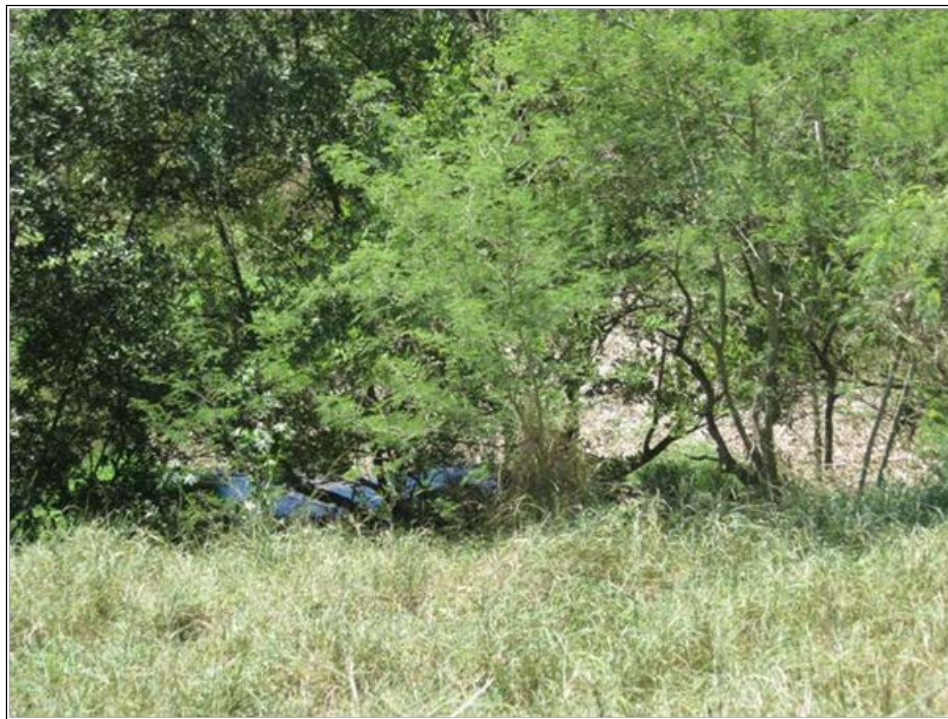
From visual inspection, the cover appeared to be a sandy clay. Exposed garbage was visible in one isolated area. The majority of the accessible portion of the landfill had established vegetation; however, the vegetated areas were scattered amongst barren areas. The side slopes also held mature, uncontrolled vegetation including large bushes, tall cotton plants, and other shrubs. No leachate seeps were found on the accessible portions of the landfill. No recent waste deposits were found at the site, and no objectionable odors or vectors were apparent on the landfill surface or accessible side slopes.

Figure 0-13. Vegetation on the Side Slopes at the Cabo Rojo Municipal Landfill

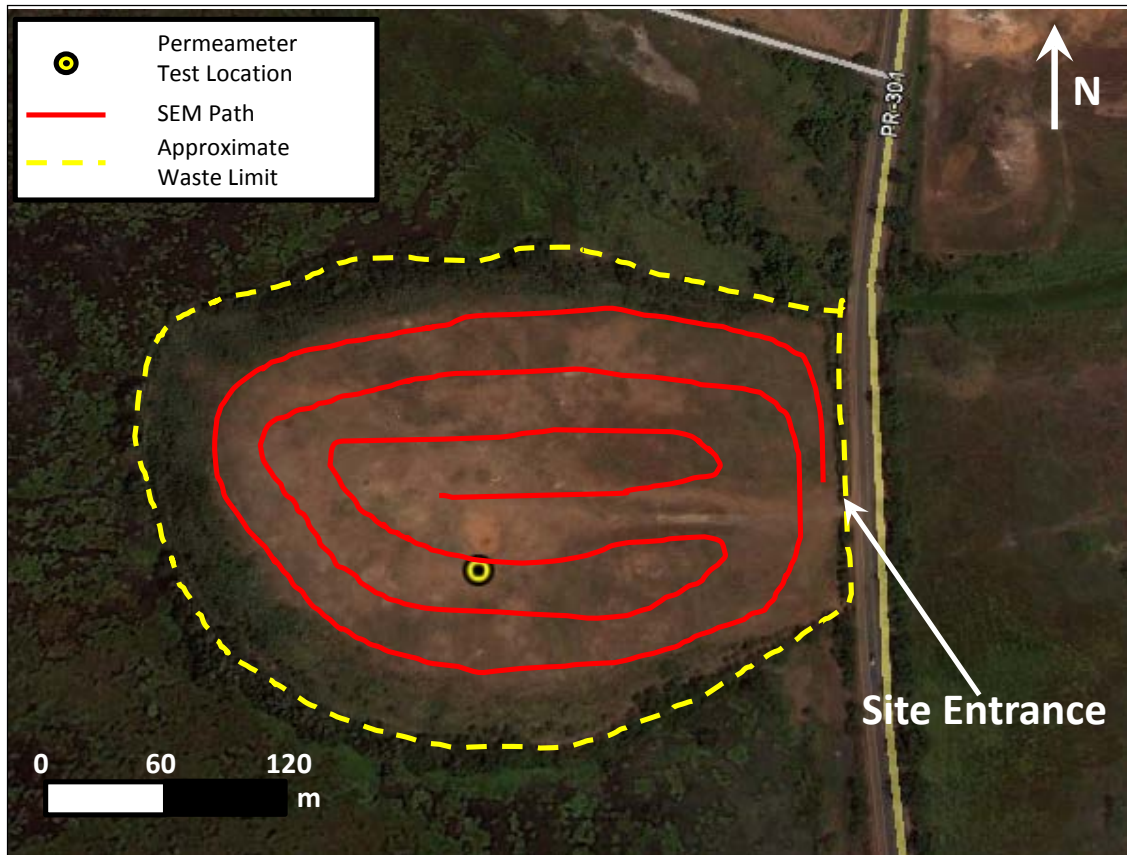
It took several attempts for the project team to obtain a hydraulic conductivity reading since the first three test holes advanced had rocks and other debris present, thus disallowing the auger from reaching the appropriate depth. The field test was ultimately conducted on the fourth borehole that was advanced. Visual classification of the soil indicated it was clayey with some silt. The measured hydraulic conductivity of the final cover soil was then measured to be 4.4×10^{-6} cm/sec. See Appendix D for the calculation of the hydraulic conductivity of the final cover soil at Cabo Rojo.

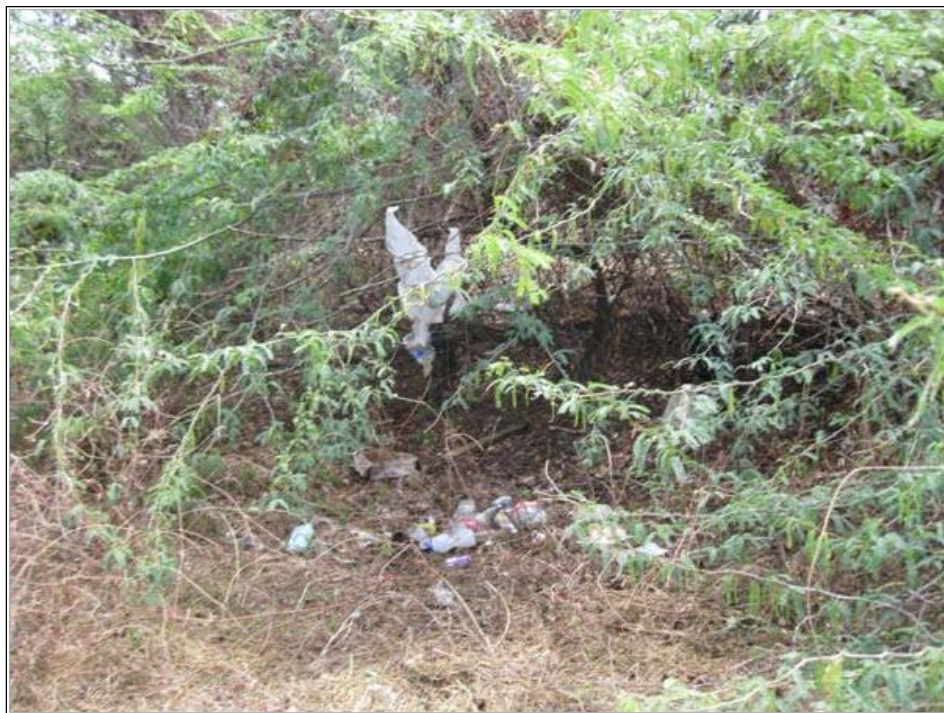
The soil at the site was a silty sand based on visual inspection. The cover thickness was variable throughout the site – exposed waste was present in several areas of the site. The landfill surface also exhibited minor undulations and surface depressions which following rainstorms likely hold water. Additionally, various pieces of debris were present in small amounts throughout the site, though it was not clear whether this material was deposited at the site before or after the landfill ceased operations. No objectionable odors or vectors were apparent at the site.

Figure 0-18. Recent Waste Deposits at the Closed Vieques Landfill

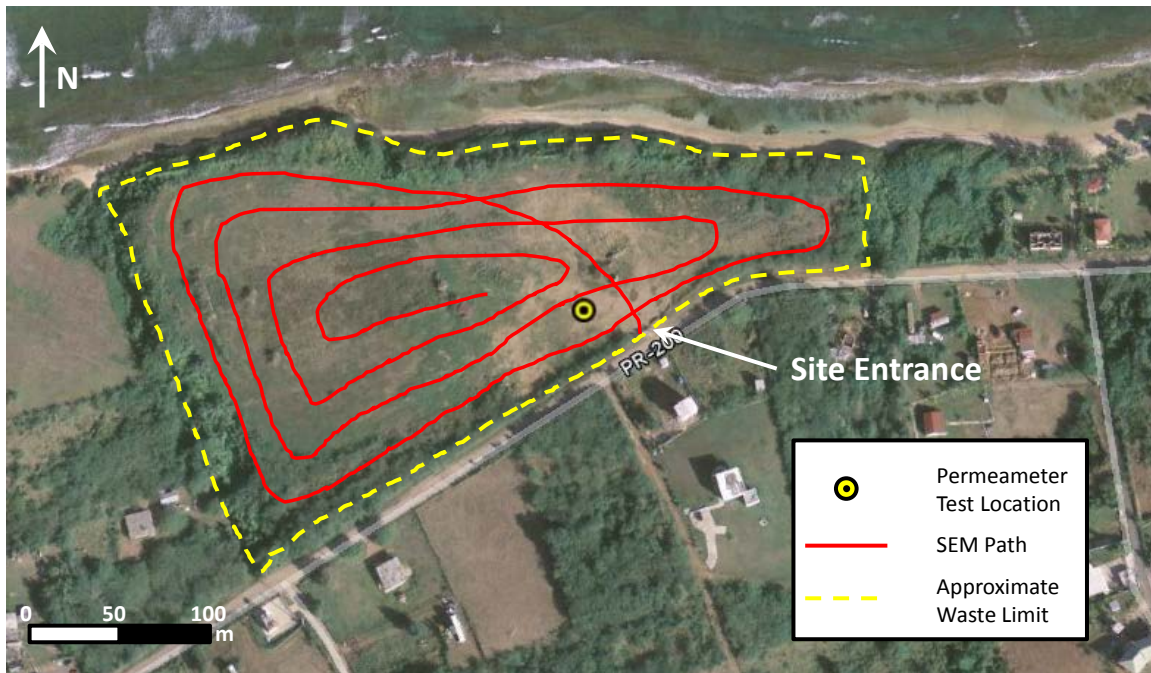
The data collected with the Guelph Permeameter was used to calculate a hydraulic conductivity of 9.0×10^{-5} cm/s. Additional details on the calculation of the hydraulic conductivity of the cover soil at the site are provided in Appendix E.

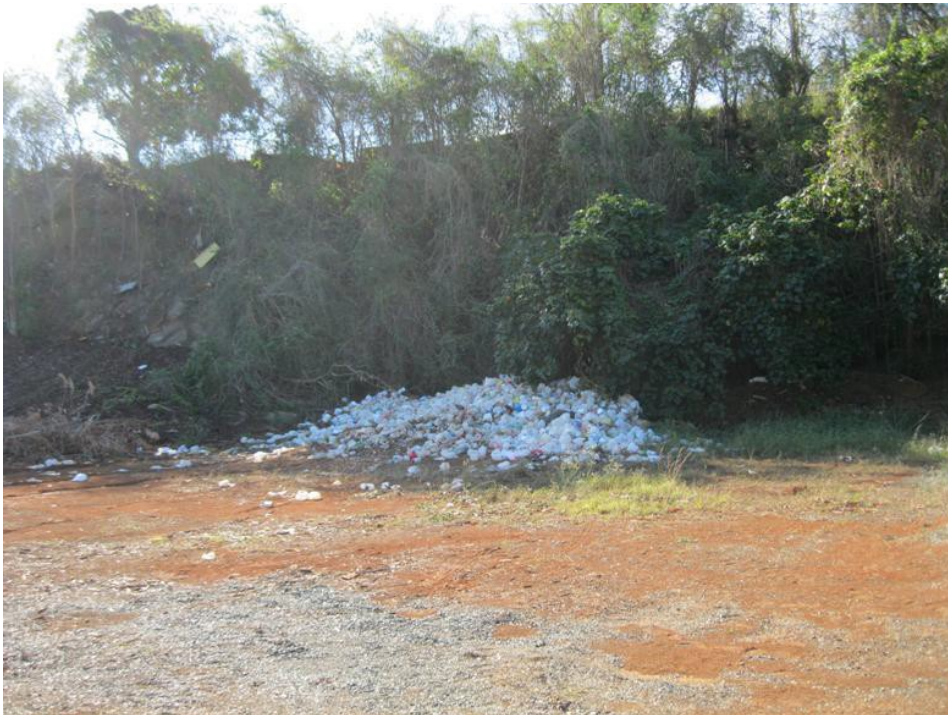
Photo #: Rincon Landfill 1-4

Stockpile of plastic bottles at the southern edge of the site

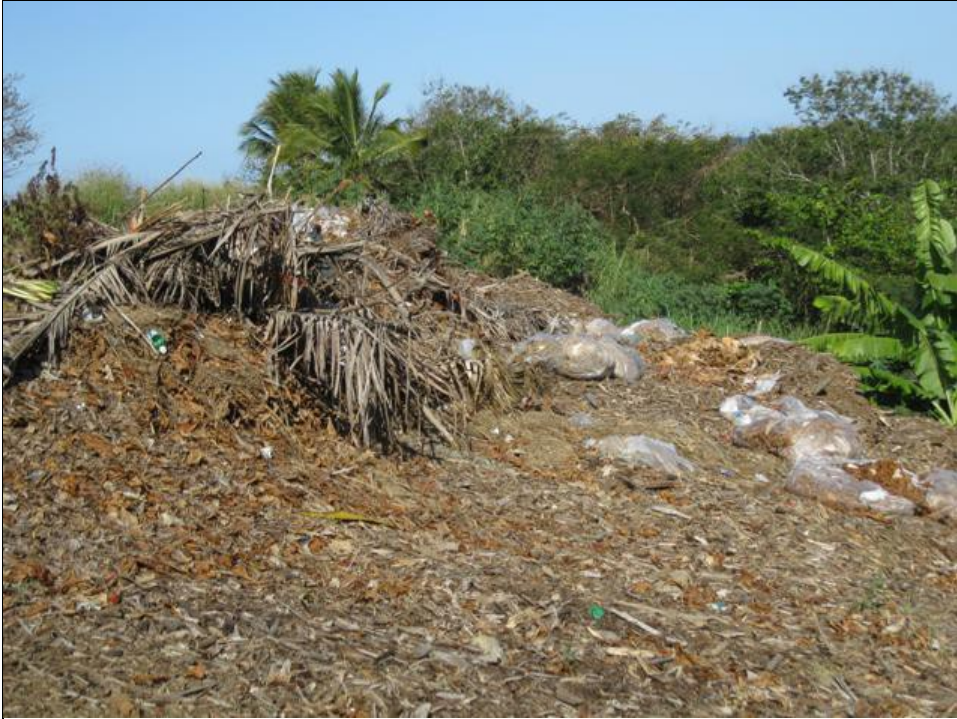
Photo #: Rincon Landfill 1-7	Description

<p>View of vegetative debris and bags with municipal waste towards the northern portion of the site. Visual inspection of the bags suggested they were placed at the site in the past few years.</p>
Photo #: Rincon Landfill 1-8	Description

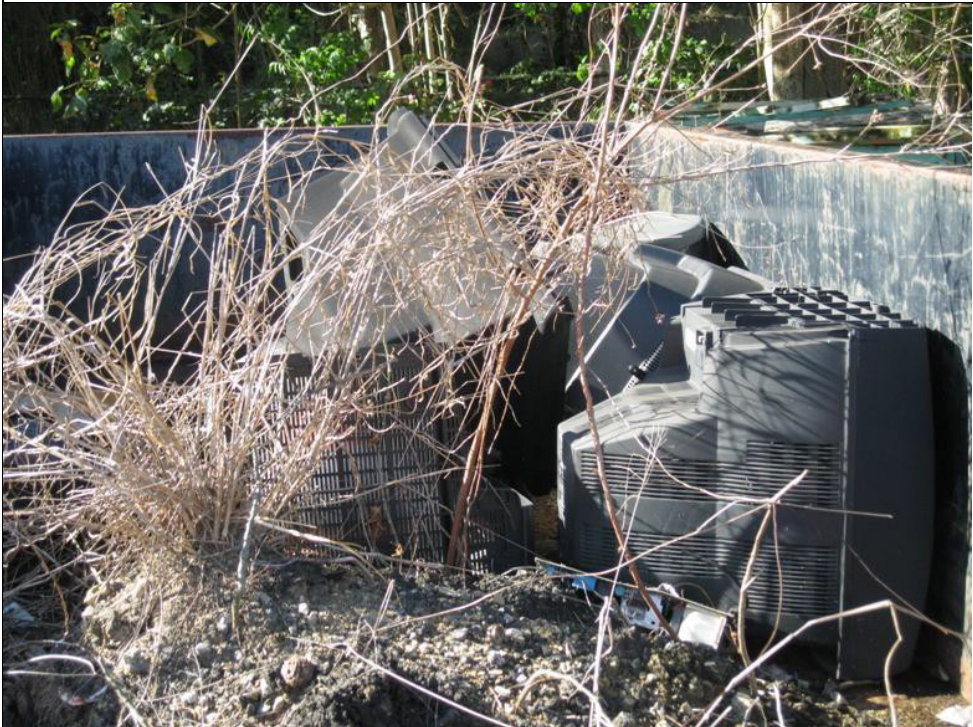
Photo #: Rincon Landfill 1-9	Description

<p>Stockpile of intact and broken cathode ray tubes that were placed in a trailer</p>
Photo #: Rincon Landfill 1-10	Description

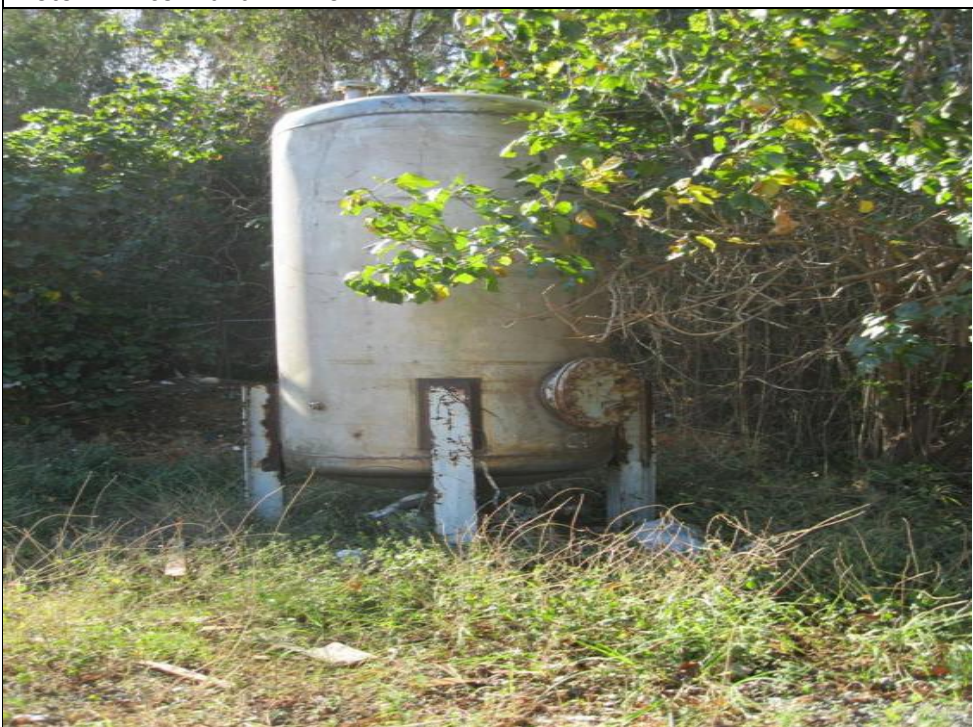
<p>Tank that was present on the southern portion of the site. The use and contents of the tank could not be determined during the site visit.</p>

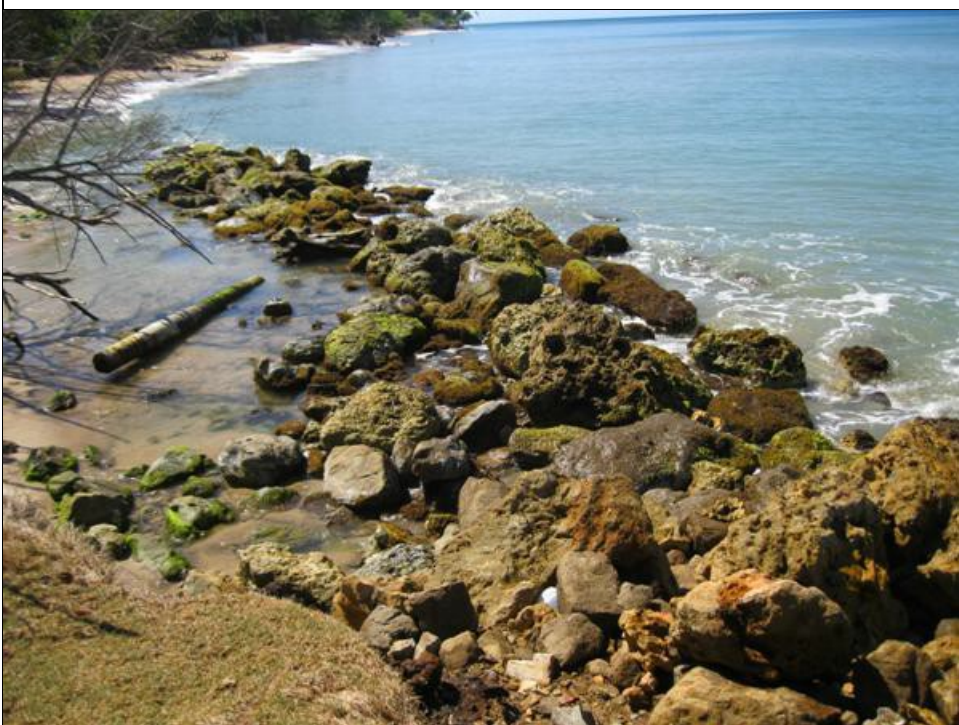
View of rocks placed near the coast. Anecdotal information from nearby residents suggested that the rocks were placed there to reduce erosion of the shore.

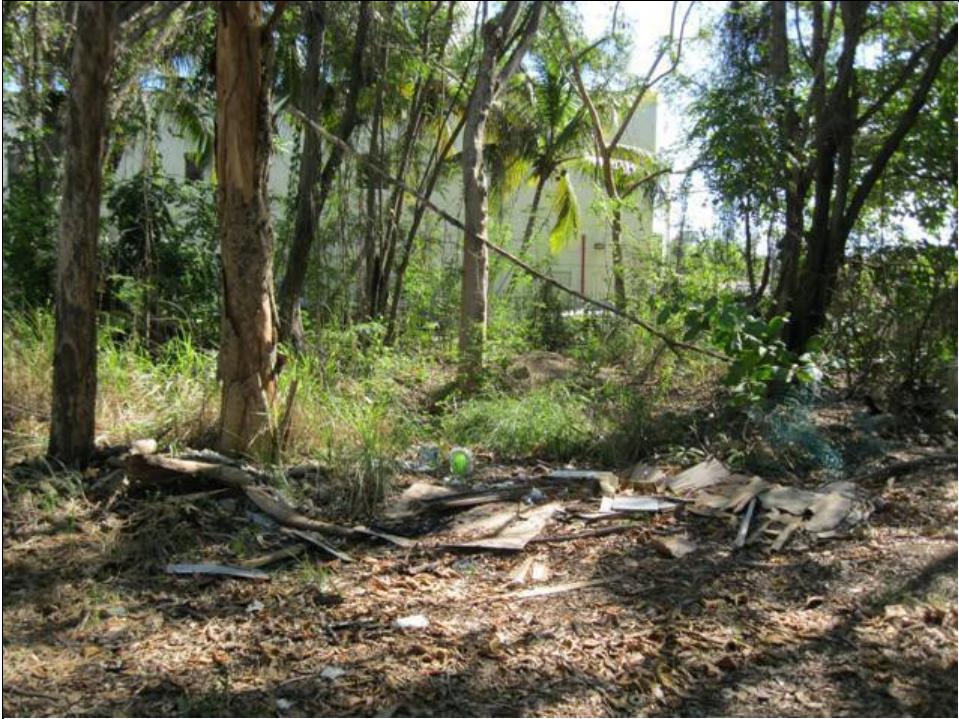
Photo #: Rincon Landfill 2-3	Description

View near the site entrance, where varying amounts of municipal waste were found.
Photo #: Rincon Landfill 2-4	Description

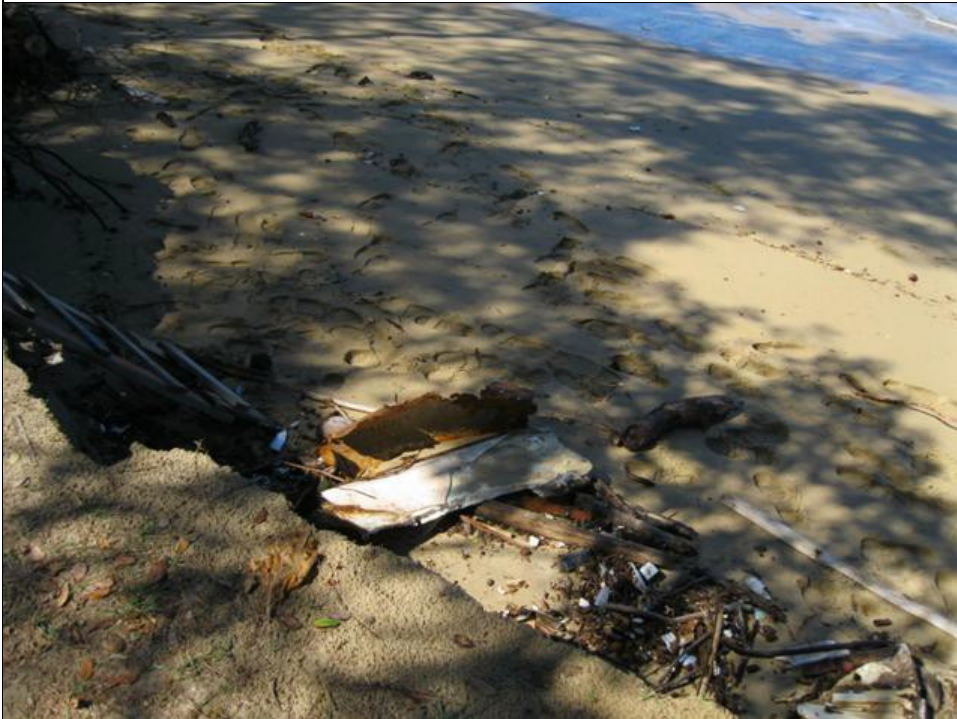
Photo #: Rincon Landfill 2-5	Description

<p>View of the western edge of the site, where debris appeared to be contacting the ocean and washing into the ocean.</p>
Photo #: Rincon Landfill 2-6	Description

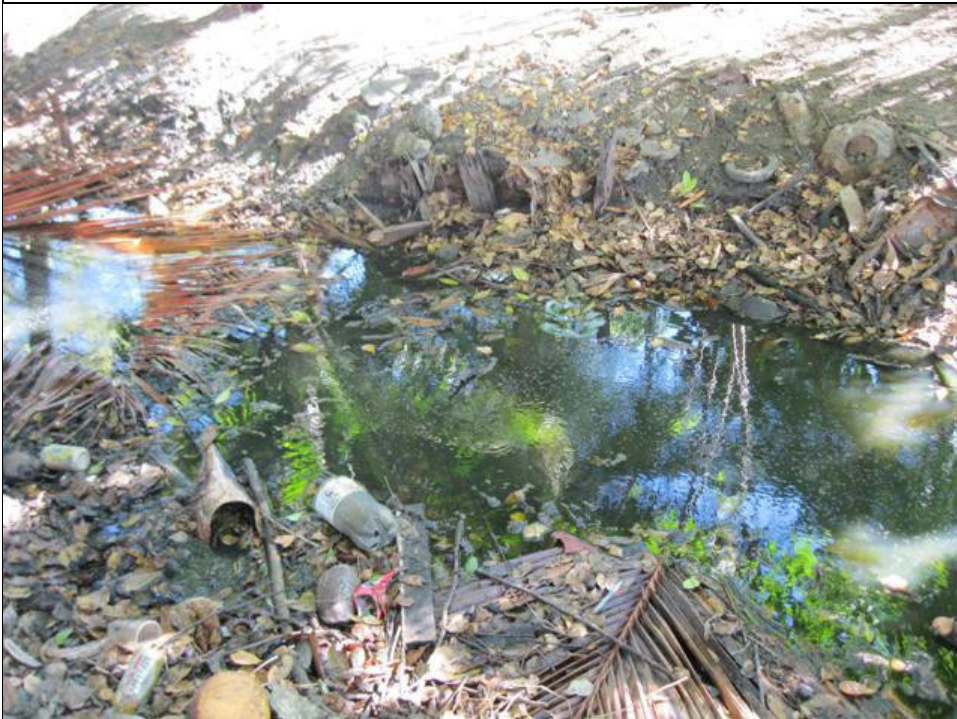
<p>View of stream on eastern portion of the site. Cans, bottles, and other debris were found to be placed adjacent to and in the stream.</p>

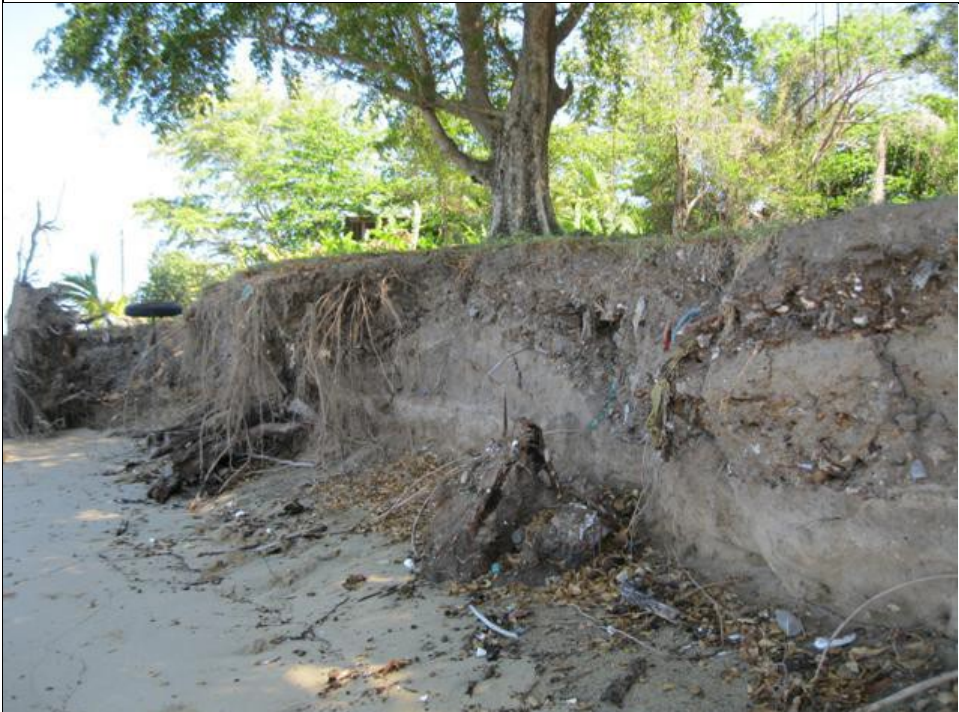
Photo #: Rincon Landfill 2-11	Description

<p>A view farther south of photo 2-11. Debris can be seen in the cross-section of the wall.</p>

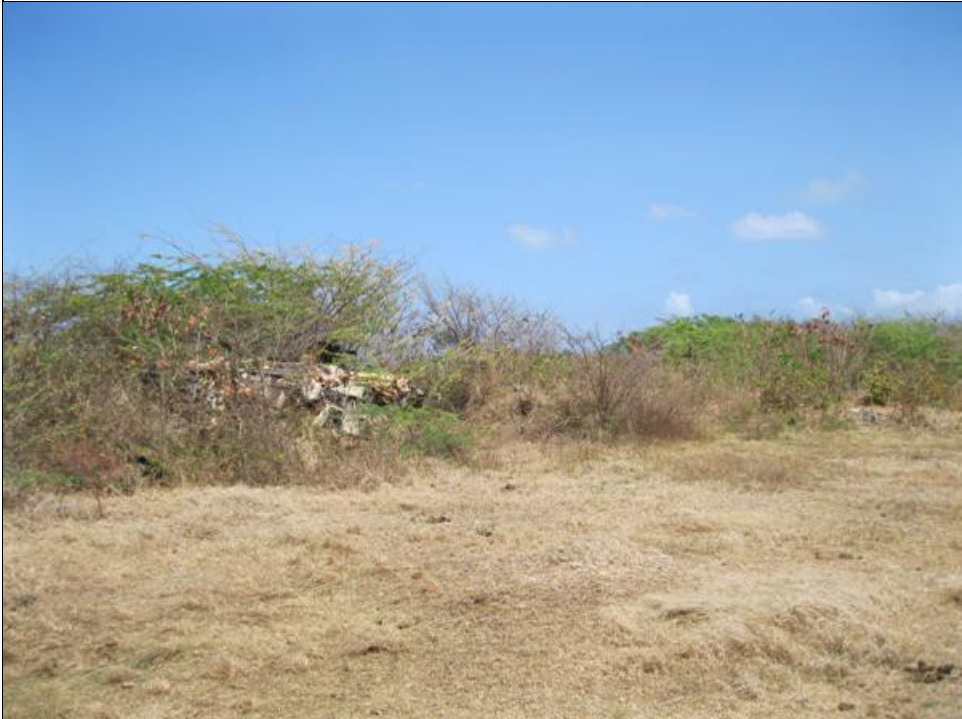
Photo #: Vieques Landfill 3	Description

<p>View of the landfill top deck. Accumulation of debris in the midground.</p>
Photo #: Vieques Landfill 4	Description
